K3 Technical Alert

Nov 17, 2009

Spurious TX sidebands due to C3 installation on early Rev C KPA3 PC boards.

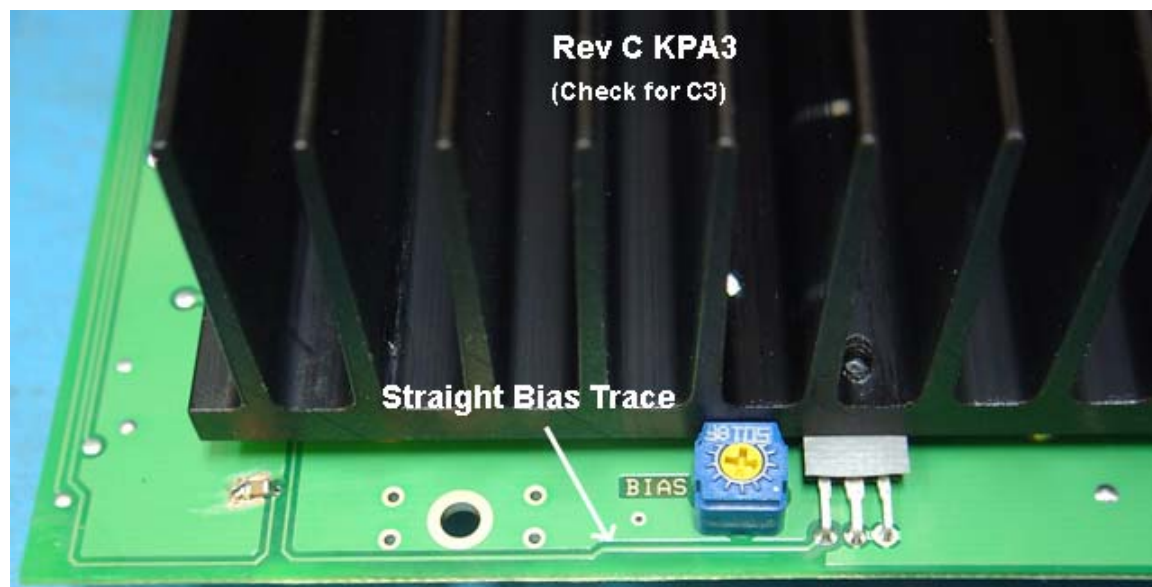
This is a Rev C KPA3. If your s/n or purchase date range is as noted above, check for installation of C3.

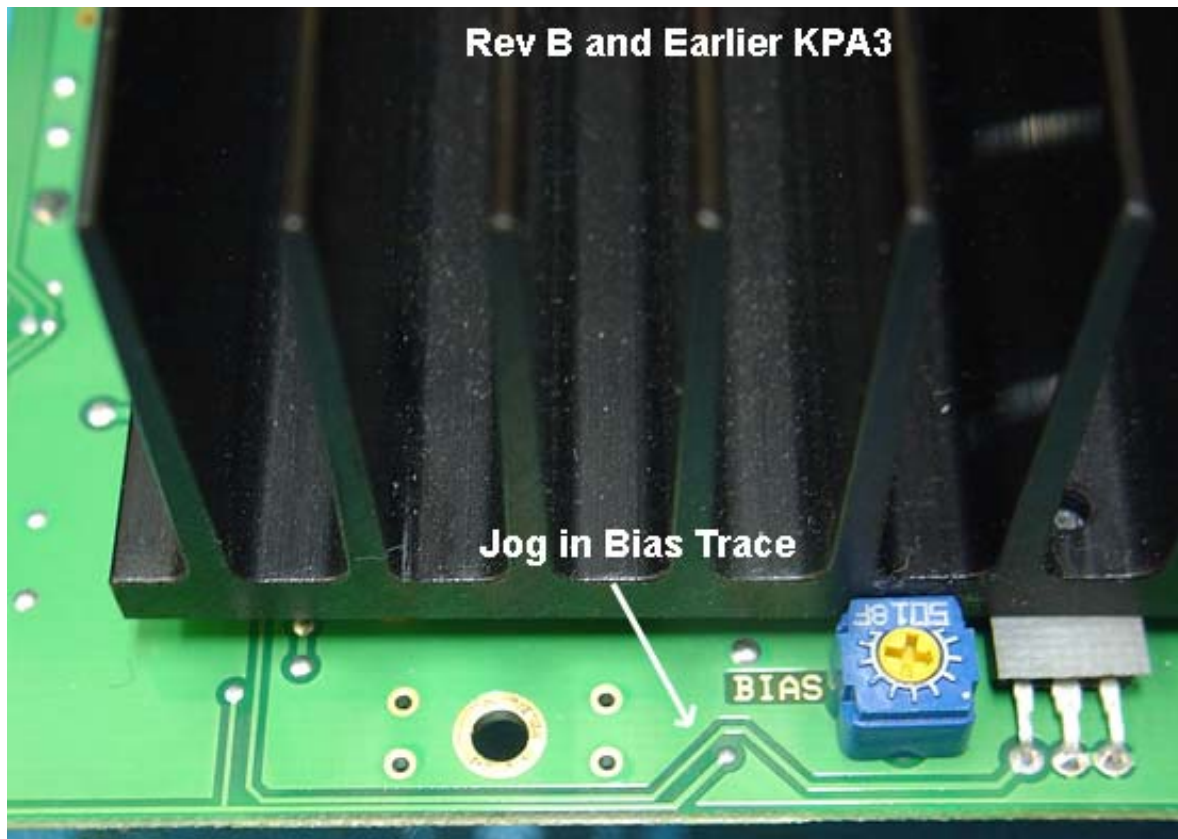
This is an earlier Rev KPA3 and does not need to be checked for C3.

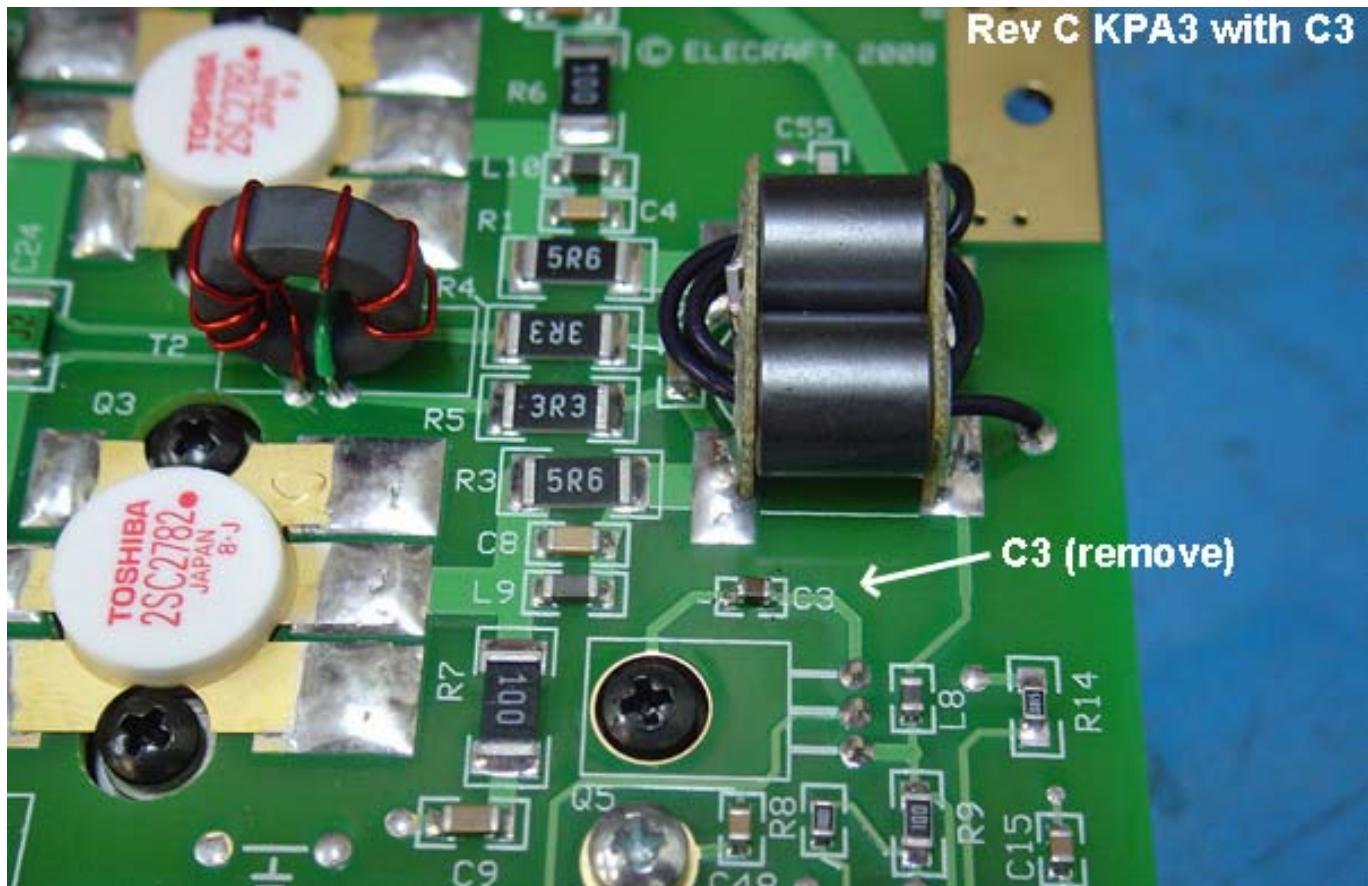
We have determined that a small number of K3/100s and KPA3s left the factory earlier this year with capacitor C3 installed by mistake on early Revision C KPA3 PC boards. This part location should be empty on Rev. C KPA3s. Installation of C3 causes the PA bias supply to oscillate on some KPA3s at approximately 15-20 kHz, resulting in spurious TX sidebands at that spacing from the carrier.

If C3 is present as shown on the above picture, remove it using a soldering iron. A 1/8" tip iron should be able to easily heat both ends of the capacitor, easily removing it from the board.
