Elecraft KX3

Improving Internal Speaker Performance

Revision A, April 24, 2013
Copyright © 2013, Elecraft, Inc. All Rights Reserved

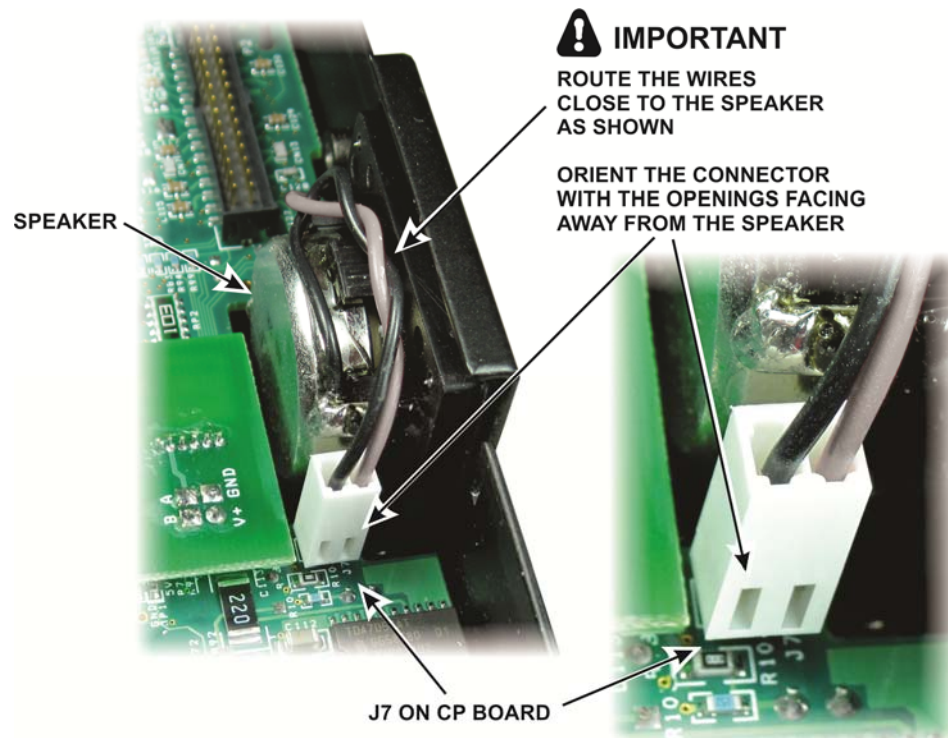
Connector Orientation

If you have occasional loss of audio or crackling sounds coming from your K3's internal speaker, especially at high volume levels, you should check the speaker connector inside the K3 to ensure it is plugged in correctly as shown below. The orientation of the connector is important. If you plug it in backwards, the connector will press against a plastic boss on the speaker housing. This can push one of the female contacts away from the male pin, resulting in an intermittent connection. The speaker audio may then cut out in a way that resembles static or saturation and distortion in the audio amplifier.

⚠ In addition to orienting the speaker connector correctly as shown below, load and use KX3 firmware revision 1.41 or later available on the Elecraft web site. Revision 1.41 modifies the audio passband and gain distribution when the internal speaker is used, reducing the possibility of distortion.
