Elecraft XV Transverter Builder's Alert

Bypass Capacitor Change

Revision B, April 30, 2009

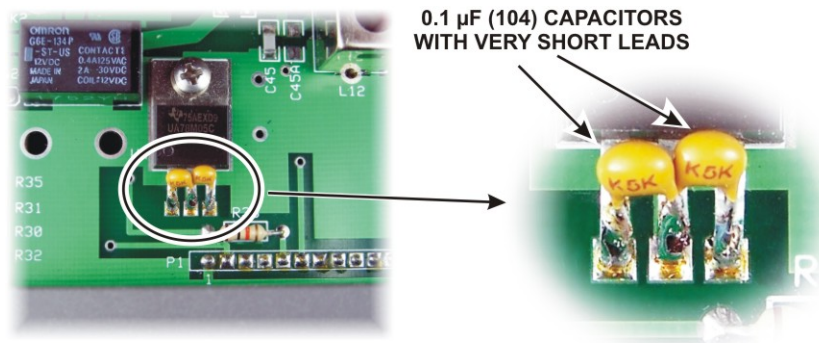
We recently discovered that the XV50, 144, 222 and 432 transverters may experience erratic behavior under certain conditions. There are two causes: RF energy entering voltage regulator U4, and voltage surges on the 5V bus caused by the relay coils.

Locate voltage regulator U4. It is just behind the front panel with a heat sink tab bolted to the pc board.

Install the two 0.1 μ F (104) capacitors between U4's center and outer pins as shown below. Solder the capacitors directly the U4's pins with very short leads. Hint: Bend the capacitor leads and hold them with your pliers while tacking one lead onto U4 with your soldering iron carrying a small drop of solder. Then solder the other lead, clean up the first connection if needed, and trim off the excess leads.

Check the resistance between the center pin and each outside pin using your DMM. It must be greater than 500 ohms to confirm no shorts between U4's pins.
